FAILURE ANALYSIS OF A 30KHZ ULTRASONIC WELDING TRANSDUCER

THESIS

Submitted in partial fulfillment of the requirements
for the degree of Master of Science in Mechanical Engineering
in the Graduate College of the
University of Illinois at Urbana-Champaign, 2010

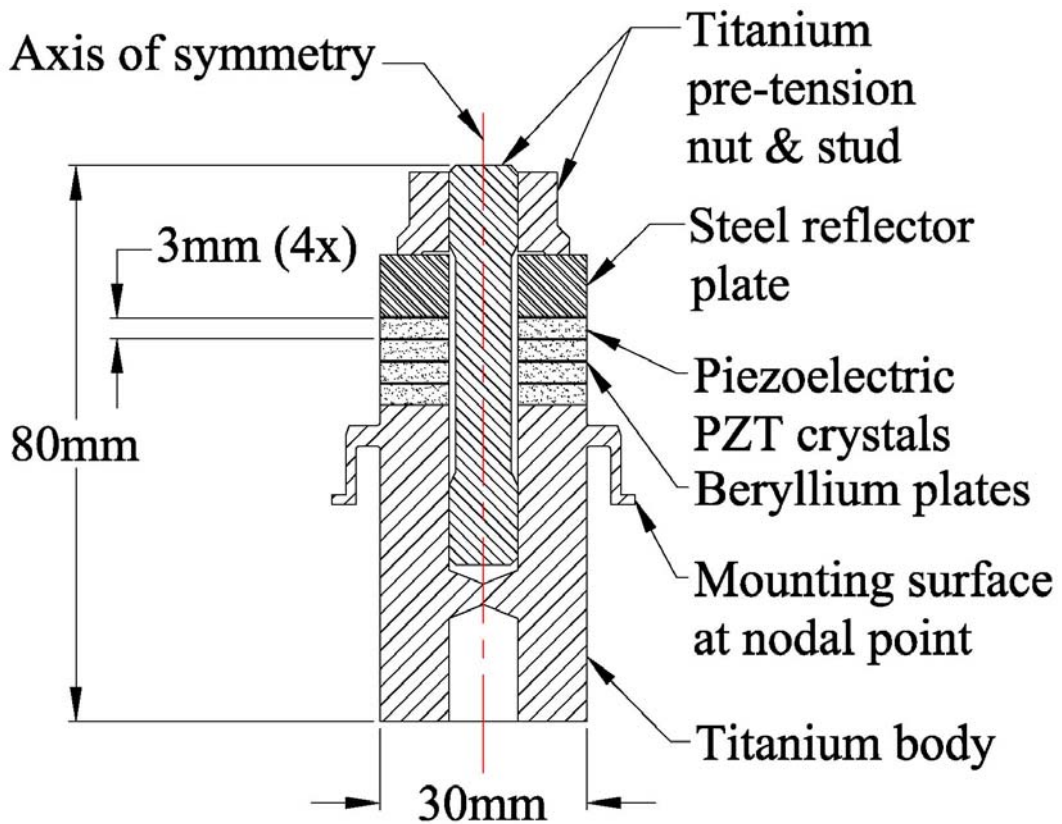
Figure 1.5 – Cross section of 30 kHz transducer

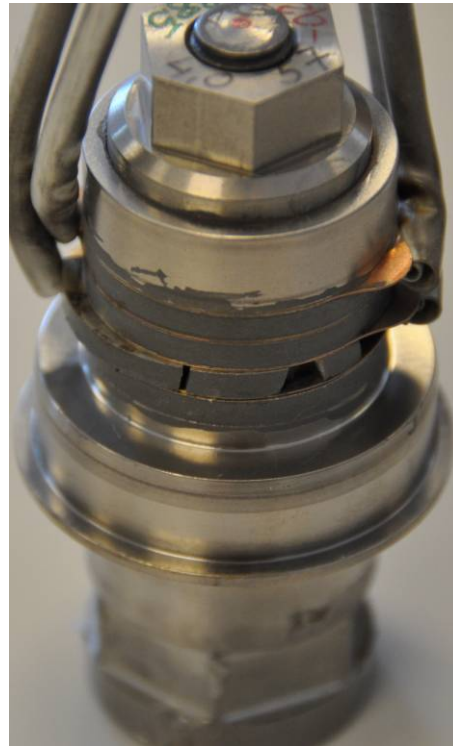
Figure 1.7 – Transducer failure due to cracked crystals

Fracture occurs when the crack grows large enough to cause the crystals to separate into multiple pieces. Even if the separated pieces do not move apart from each other the fracture surfaces are no longer perfectly coupled, which allows relative motion leading to friction and rapid overheating [3]. Poor coupling at the interface causes the resonant frequency to change, creates unequal electrical properties and allows a short circuit path for high voltage arcing. Cracks initiate at either pre-existing cracks/voids or they are formed by tensile loads, impact stresses or shear stresses [4]. Figure 1.7 is a picture of a converter failure due to cracked PZT crystals.

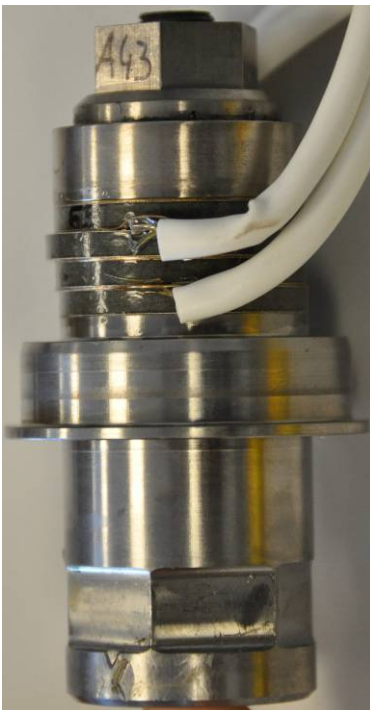
Figure 1.8 – Transducer failure due to shifting crystals

and internal stresses increase in the crystals. In many cases, shifted ceramic crystals also lead to fracture. Figure 1.8 shows converter failure due to shifted crystals.

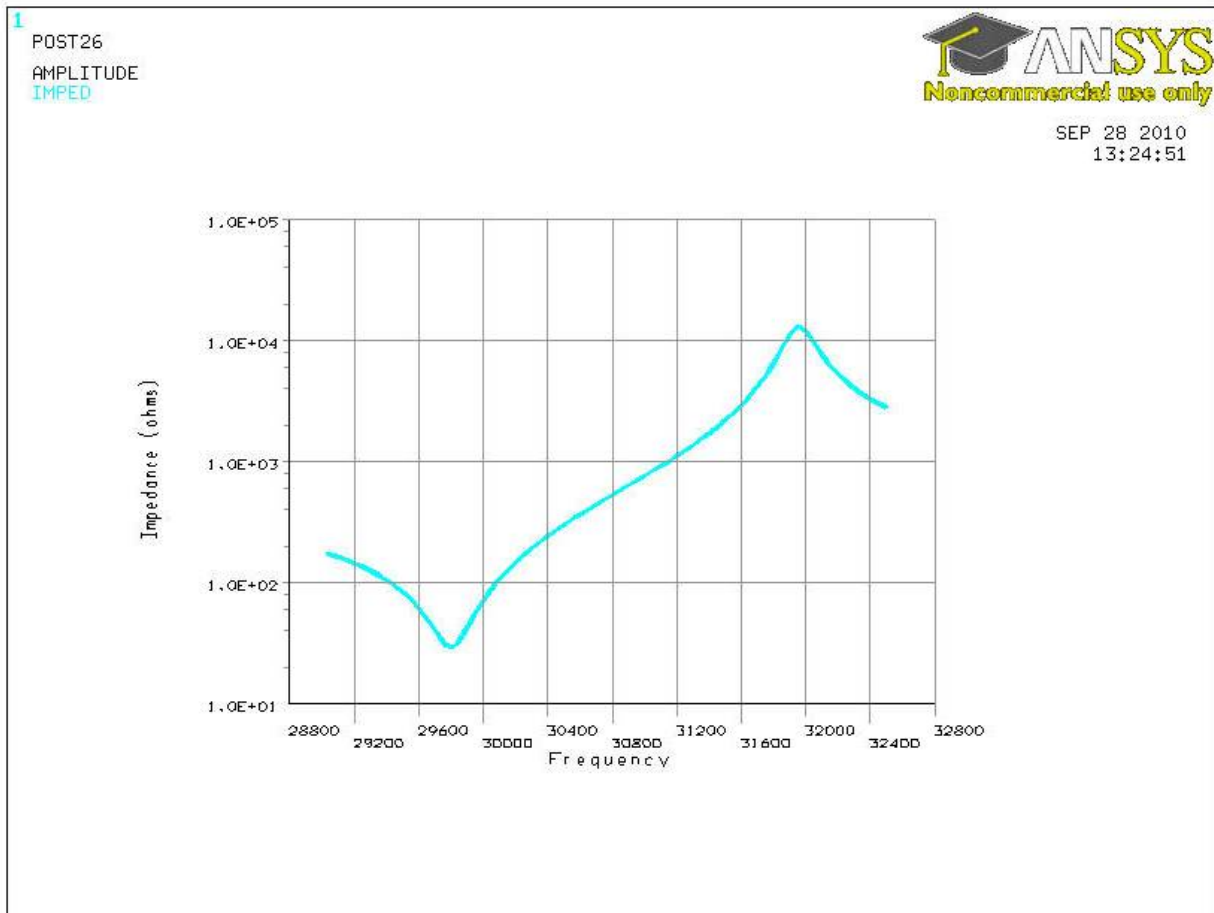
Figure 3.8 – Impedance versus frequency plot from 29,000-33,000 Hz

The harmonic analysis was performed with a frontal solver using a full solution method with stepped boundary conditions. The resulting impedance plot is shown in figure 3.8. The impedance is calculated from the voltage boundary condition and a calculation for the current based upon the charge. The plot of the amplitude or y-displacement at the coupling surface is shown in figure 3.9. Figure 3.10 is another amplitude plot from 30,650 to 30,750 hertz with 1 hertz increments to find the exact frequency producing 7.5 microns. This plot clearly shows that 30,700 hertz is the correct point. Figure 3.11 shows the Von mises stress distribution with maximum displacement at 30,700 Hertz. Figure 3.12 shows the same distribution only within the piezoelectric transducer crystals to more clearly illustrate this critical area.

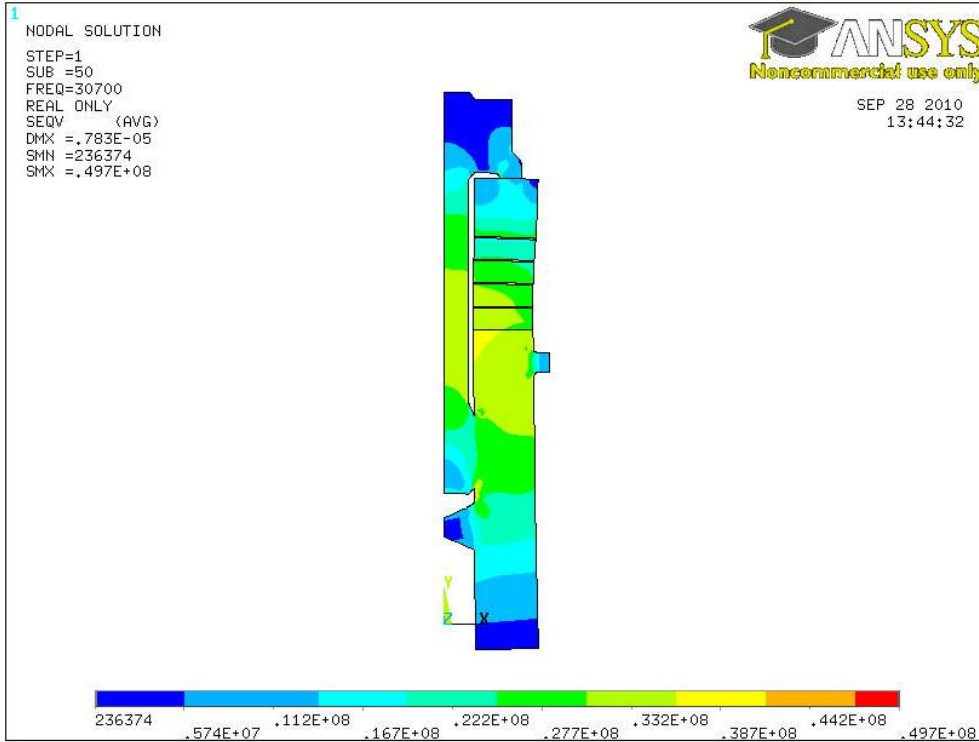
Figure 3.11 – Von Mises stress distribution at 30,700 hertz

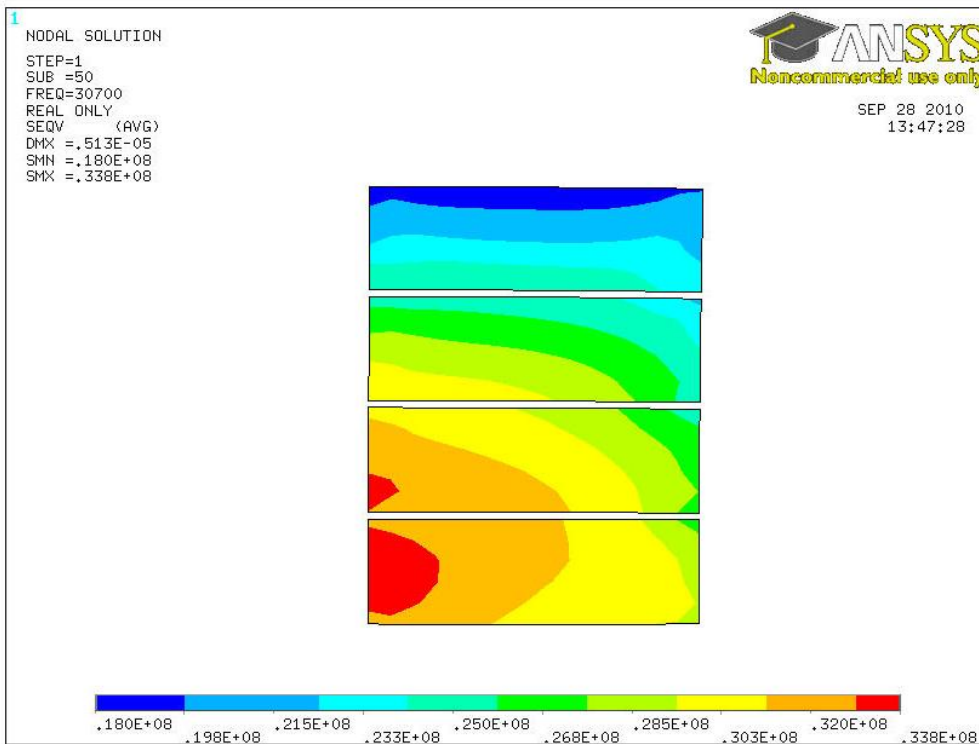
Figure 3.12 – Von Mises stress distribution at 30,700 hertz, only showing piezoelectric crystals

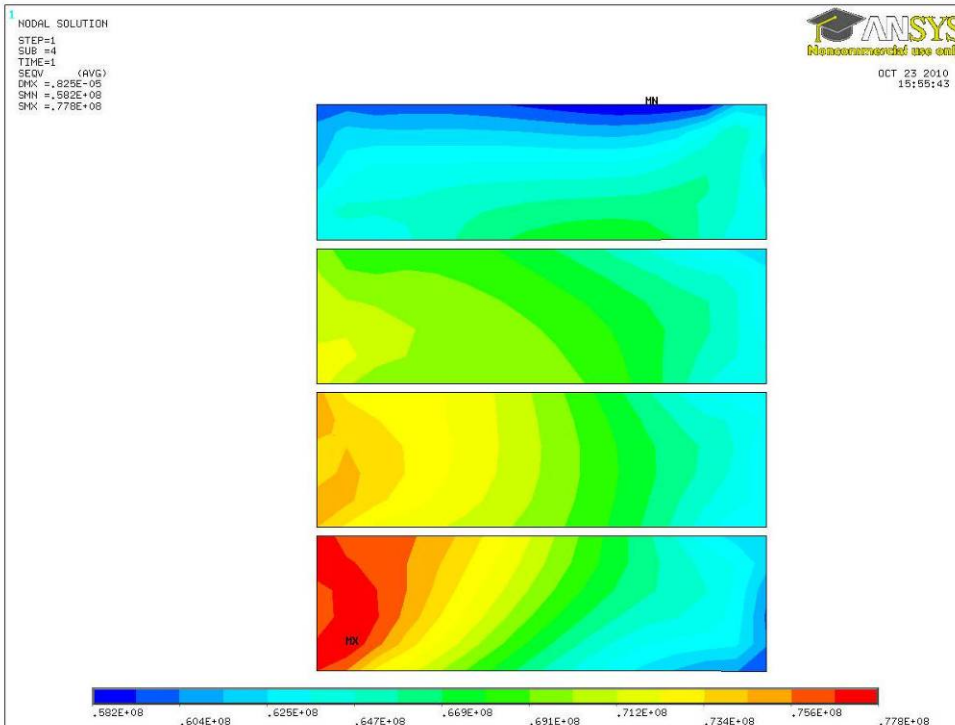
Figure 3.14 – Von Mises stress distribution under static load at ceramic crystals

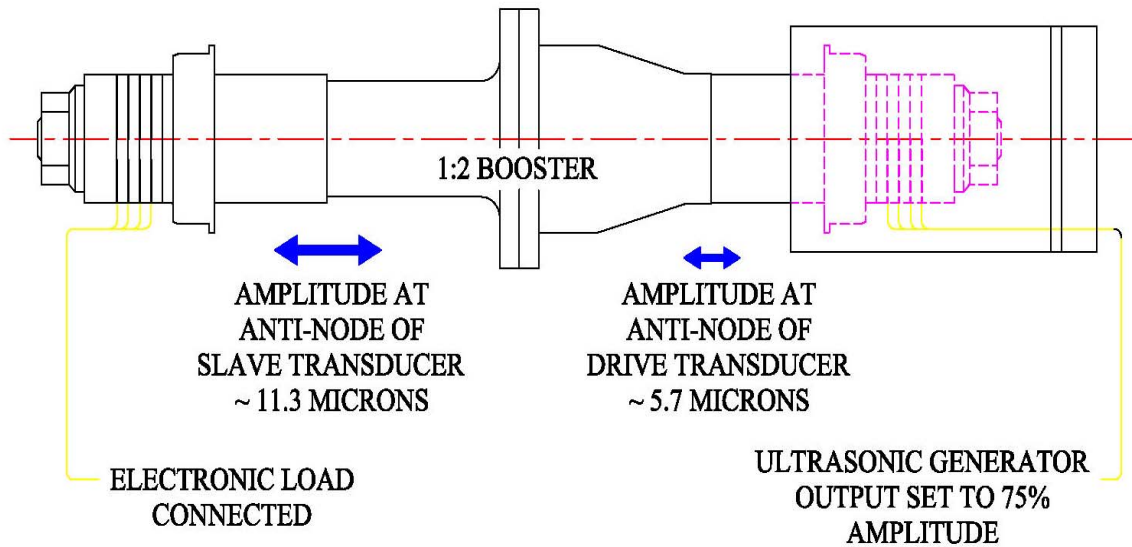
Figure 4.1 – Drive and slave transducer set-up – (a) configuration of vibrating stack for testing, (b) configuration creating nominal stress values in slave transducer, (c) alternate configuration to create nominal stress values in slave transducer, (d) configuration creating 150% overstress in slave transducer

In order to induce failure in the piezoelectric transducer under high amplitude conditions to study the failure mode, a vibrating stack consisting of a drive+slave transducer combination was used. This same set-up has been used in past experiments and is currently used as a way to perform endurance tests on ultrasonic generators under electronically loaded conditions. This is done because there is no practical way to mechanically load a vibrating stack with the same conditions encountered in production. In this drive+slave configuration the drive transducer is subject to electrical loads typically encountered during welding. With this arrangement, the slave transducer can be overstressed in a controlled manner based upon the booster size, generator setting and the manner in which the piezoelectric crystal is electrically connected. Figure 4.1 shows the basic set-up of this vibrating stack as well as several examples showing how to create normal and overstressed conditions within the slave transducer. The slave transducer is considered overstressed when the input amplitude at the coupling surface is greater than 7.5 microns, which is normally the maximum or nominal operating limit of the system. In figure 4.1d the generator is set to 75% resulting in a drive transducer output of 5.7 microns, which is 75% of 7.5 microns. The booster will amplify this value and double it based upon its gain ratio, generating 150% of the nominal stress level or ~11.3 microns in the slave transducer. Figure 4.2 shows a picture of the vibrating test stack. Figure 4.3 shows a schematic of the overall set-up of the experiment. Figure 4.4 shows pictures of the actual laboratory set-up used during the experiment.

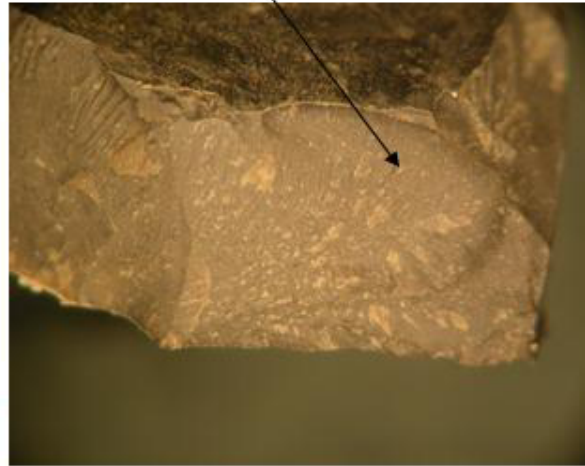
Fracture surface due to fatigue, irregular surface

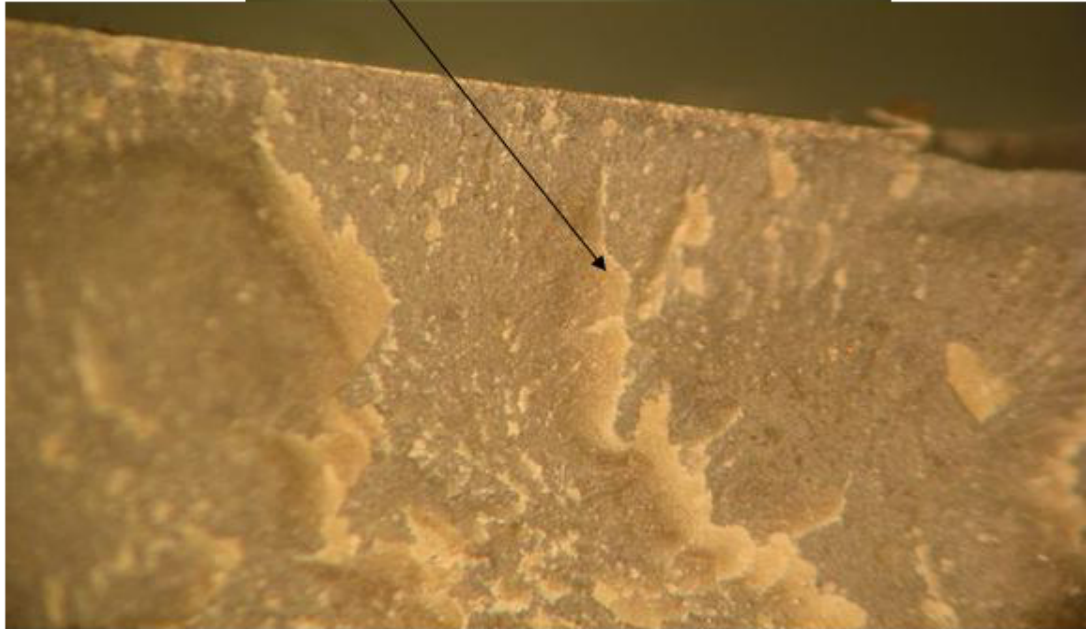
Fracture surface due to fatigue, irregular wave-like pattern
